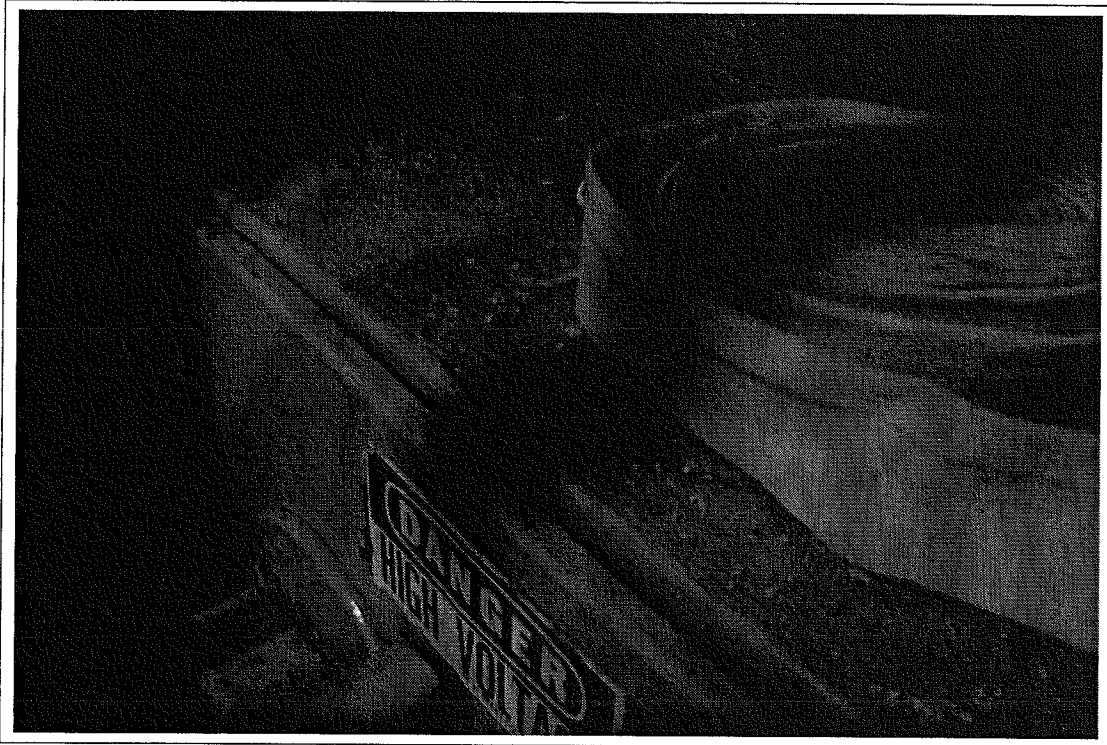
Photo 16. B floor east mechanical rm – view of breaker box and fireproofing debris below ladder (sample # 2)

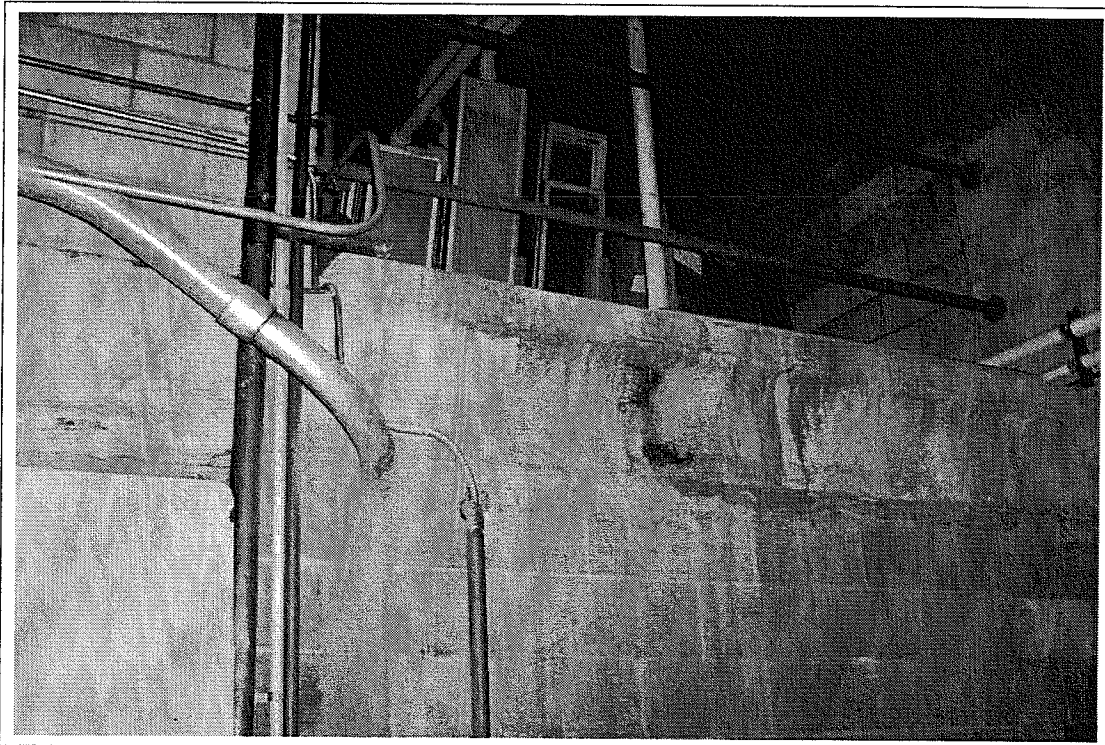
Photo 17. B floor east mechanical rm – damaged fireproofing on exposed I-beam

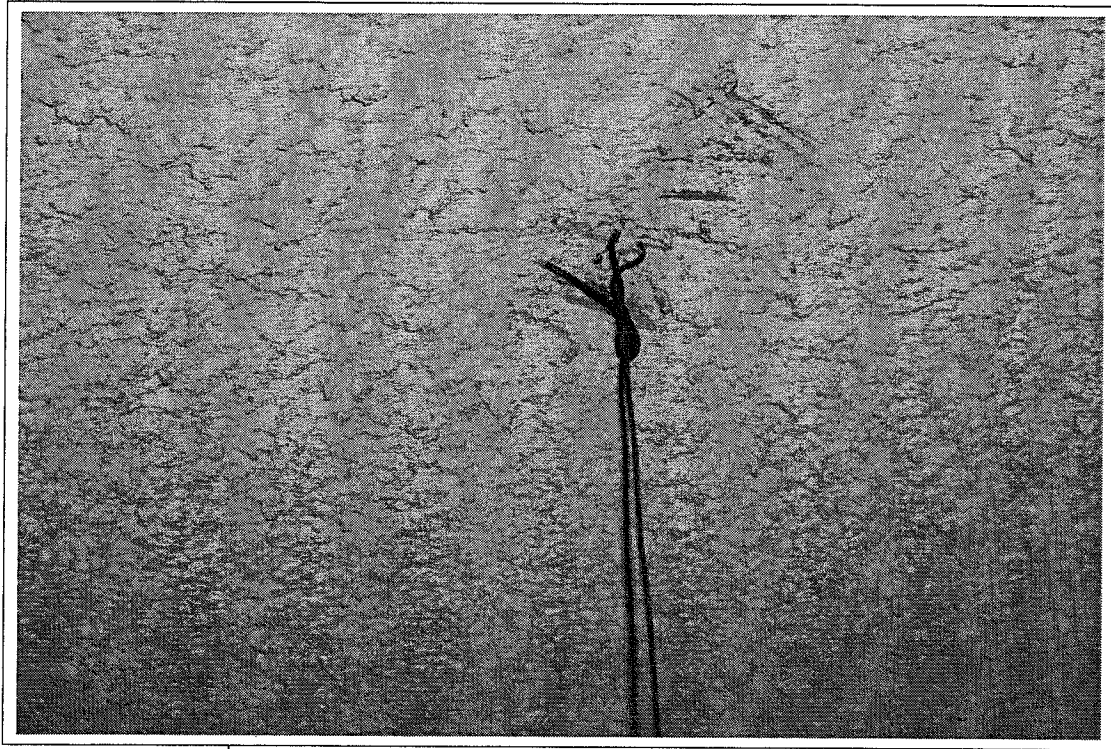
Photo 18. 2nd floor suite 261 – impacted fireproofing on deck next to hanger wire

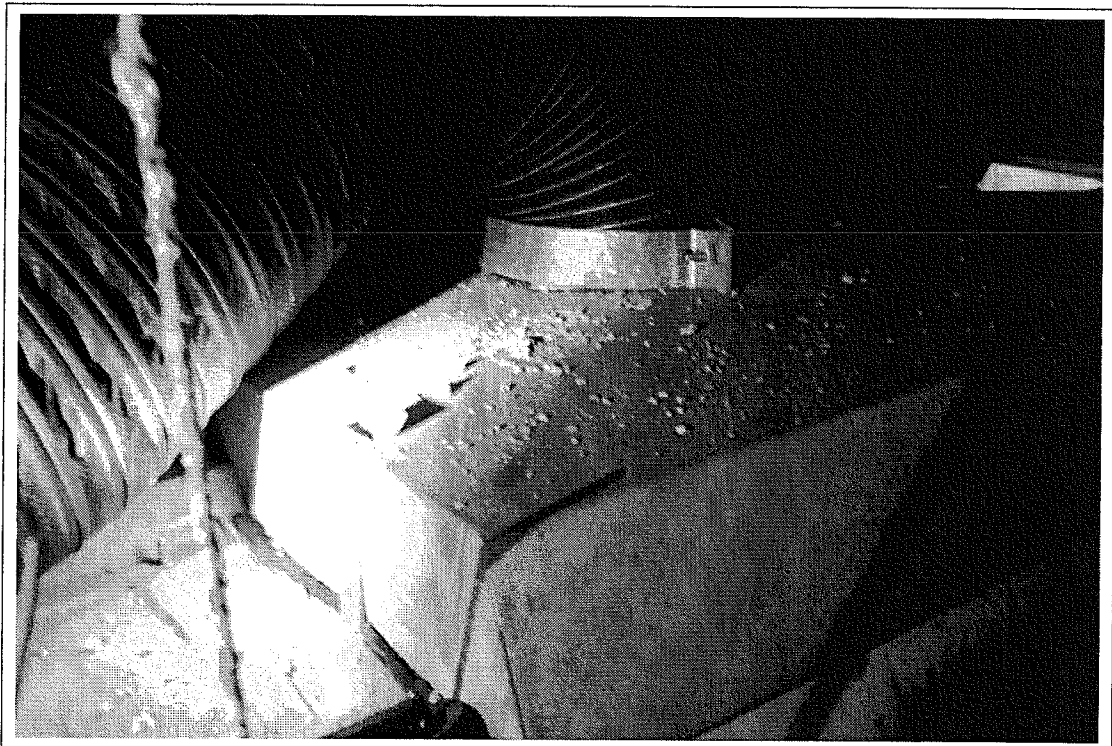
Photo 19. 6th floor center suite 600 – close-up of fireproofing debris on top of fluorescent light fixture in plenum
